KLINGE CORPORATION

TECHNICAL SERVICE BULLETIN

Subject: Return Probe Location	Bulletin No: 060619
	Last Issued: June 19, 2006

Regarding: New location of thermostat Probes for Improved Defrosts

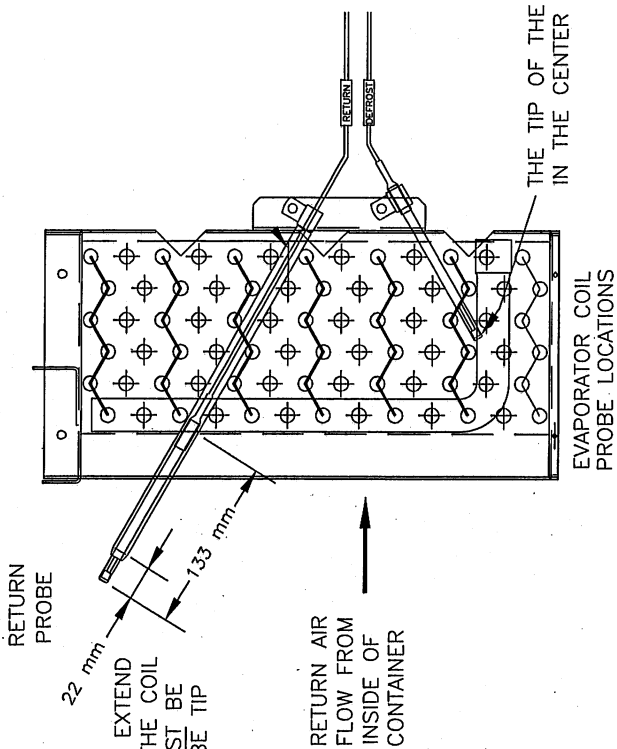
REFERENCE - THE TEMPERATURE SENSOR IS LOCATED AT THE TIP OF THE PROBE

THE TIP OF THIS PROBE MUST EXTEND 133 mm FROM THE FINS OF THE COIL AND THE INSULATING TUBE MUST BE 22 mm BACK FROM THE PROBE TIP FOR PROPER UNIT OPERATION

CAUTION
 CARE MUST BE TAKEN WHEN INSTALLING THE PROBES IN A NEW COIL. TO PREVENT DAMAGE TO THE COPPER TUBES WE SUGGEST USING A SMALLER BLUNT TIPPED ROD TO BEGIN MAKING THE CLEARANCE HOLE FOR THE PROBE. DO NOT MAKE THE HOLE OVER SIZE.

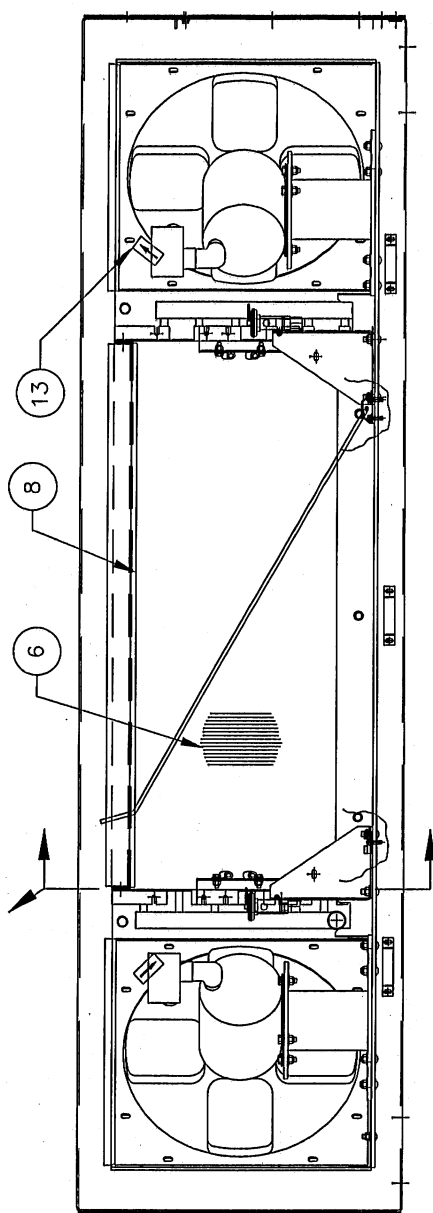
EVAPORATOR VIEW

THE TIP OF THE DEFROST PROBE MUST BE IN THE CENTER OF THE COIL AS SHOWN
